Re: Inspection of MidAmerican Energy Company's Bettendorf Transmission and Distribution Units for Compliance with Natural Gas Pipeline Safety Standards  
Docket Nos: RG-0156, P-0148, P-0451, P-0729, P-0831

MidAmerican Energy Company (MidAmerican) provides the following response to the December 24, 2019, notification letter from Mr. Magid Yousif.

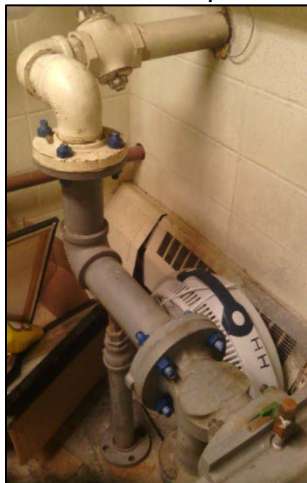
**Probable Violation 192.147(a)**

Flanges and flange accessories: One meter setting was found with short bolts that did not fully engage the connecting nut at Hoover Elementary School - inside school gymnasium.

*MidAmerican replaced bolts that were not fully engaged.*

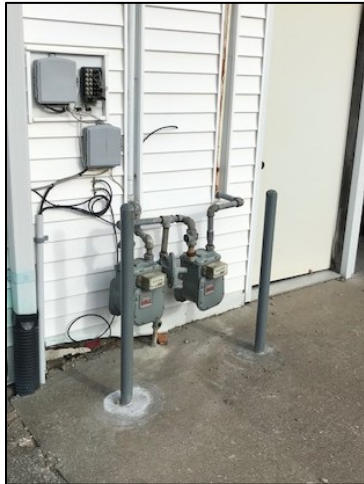
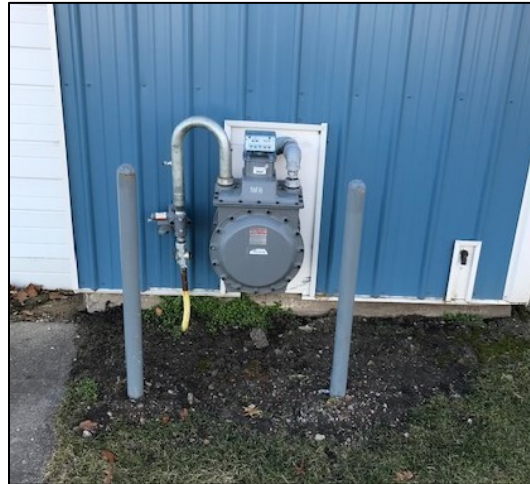
- 1) 120 (actual 118) W 4<sup>th</sup> St, Wilton    2) 105 E LeClaire, Eldridge

The field inspection found a three locations where a bollard is needed to protect the setting from vehicular damage, and also found a meter contacting the soil would need to be protected from corrosion of the meter casing.

- 1) 120 W 4th Street, Wilton
- 2) Public Works, 105 E Le Claire, Eldridge
- 3) 108 East 4th Street, Wilton

*MidAmerican installed bollards at the following locations:*

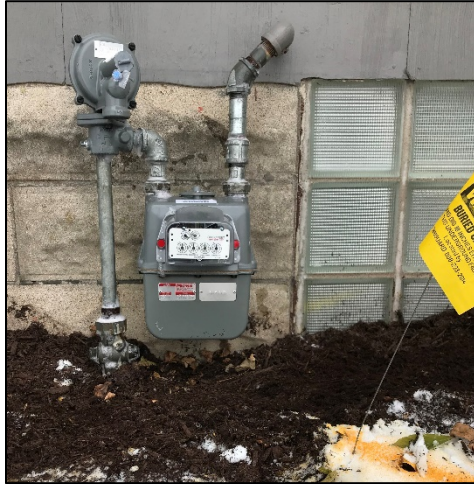
- 1) 231 E Gennessee (actual Mayne) St, Blue Grass

Meter partially buried :

- 1) 231 East Genesee, Blue Grass

*MidAmerican rebuilt the meter set to eliminate meter contact with soil at the following location:*

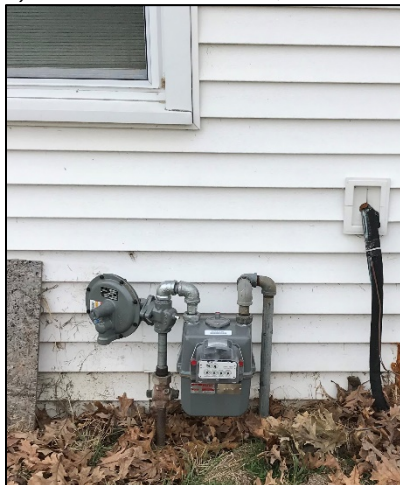
- 1) 12160 S Utah Ave, Buffalo

The field inspection found four instances where a regulator vent was located near an opening into a building.

*MidAmerican installed IMN (internal monitor) regulators or vent lines at the following locations:*

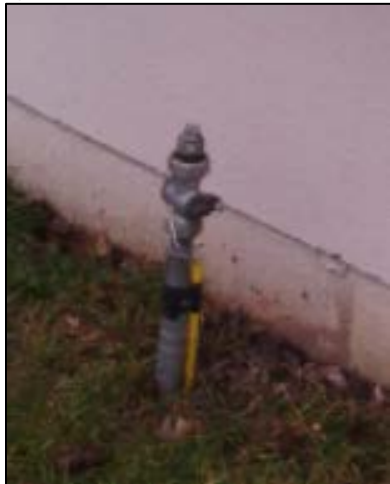
1) 2600 Shoreline Dr., Bettendorf

The field inspection found one instance of inadequate installation placing stress on a meter:  
2600 Shoreline Dr., Bettendorf

*MidAmerican removed the meter bar, plugged and pinned the shut off valve in the closed position at the following location:*

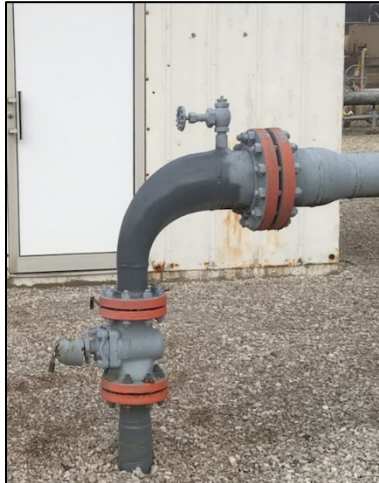
The field inspection found twelve instances of above-ground pipe which needed wrap or coating repair to maintain protection from atmospheric corrosion: 192.481(b)

1) TRS #303 Riverdale, Riser 3061  
*MidAmerican rewrapped the riser.*

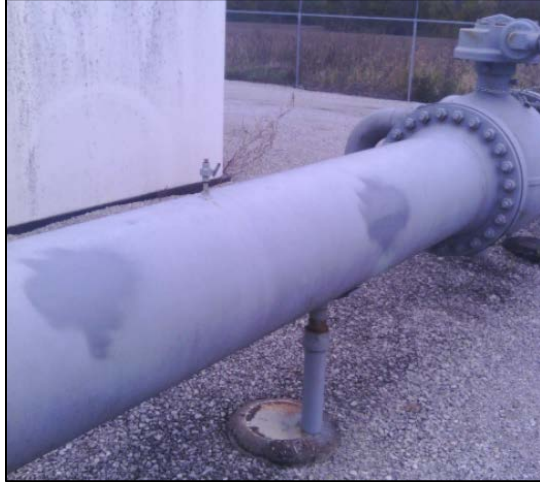
1) Linwood TRS 0069

Field Inspection also found five above-ground pipes with active atmospheric corrosion:  
192.479(b)

*MidAmerican cleaned and painted the pipe.*

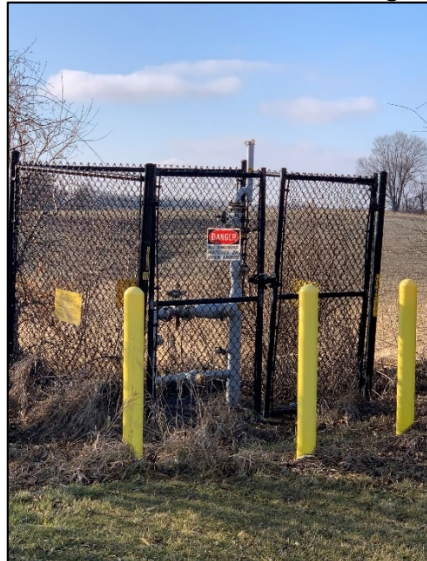
The field inspection identified three instances of regulator stations improperly protected from conditions that could prevent proper access or operation:

- 1) DRS #0286 Hickory Grove Rd  
*MidAmerican removed the vegetation.*

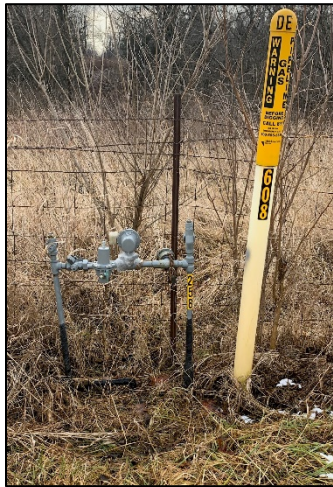
2) DRS #003 Hwy 61, Muscatine

*This was determined to be station 258. MidAmerican reviewed and determined the station is accessible.*

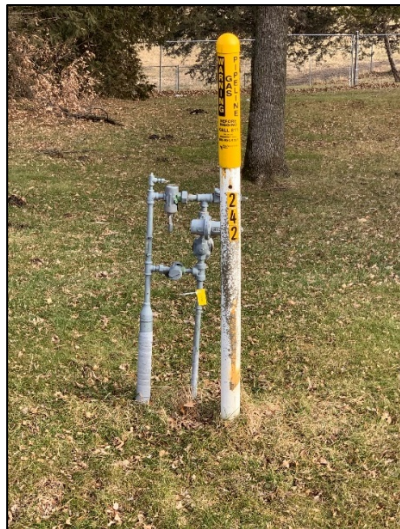
3) DRS #0242 On South Utah Ave, Buffalo

*MidAmerican reviewed and determined the station is accessible.*

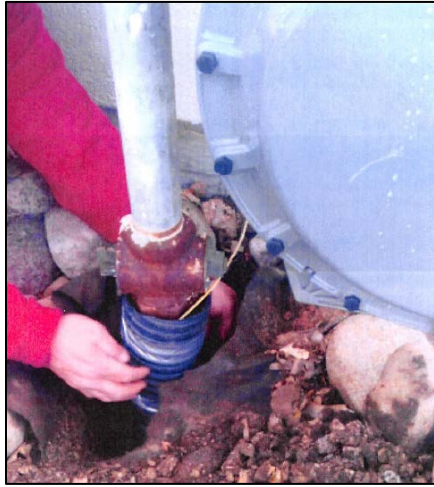
1) Admissions Center, St Ambrose

Inspected steel pipes are cathodically protected from corrosion with the exception of four locations where the crimp on the anodeless riser was found buried below the surface, leaving a short, unprotected section of pipe:

*MidAmerican installed corrugated tubing to eliminate contact between gas carrying metallic pipe and the soil.*

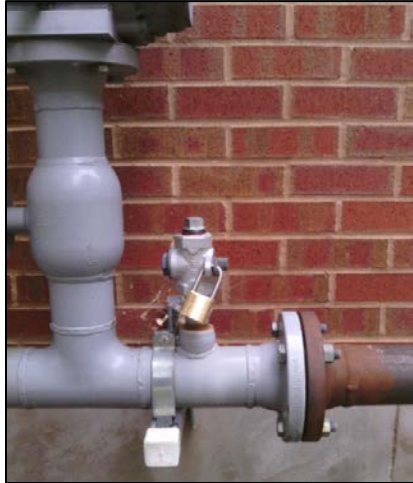
Book Store Saint Ambrose University, 330 West Pleasant Street

The field inspection identified one instance of an open facility which requires a locking device.

*MidAmerican installed a plug and lock.*

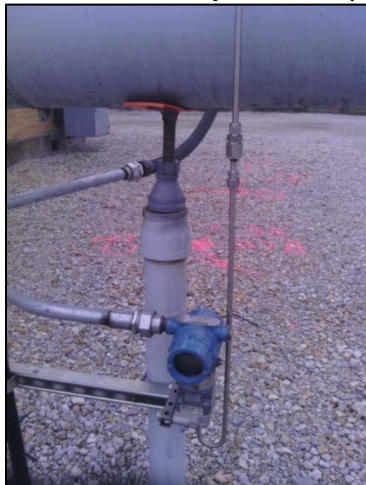
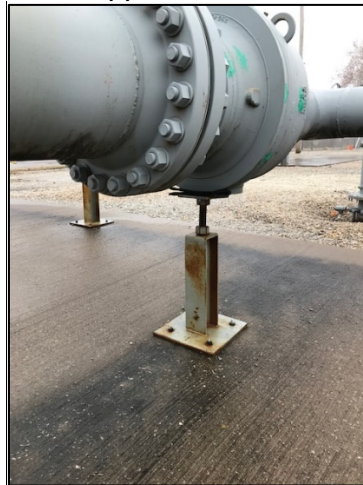
- 1) TBS#0122 West Locust St, Davenport

The field inspection identified four instances of movement of the pipeline causing disengagement of the support equipment:

*MidAmerican adjusted the pipeline supports.*

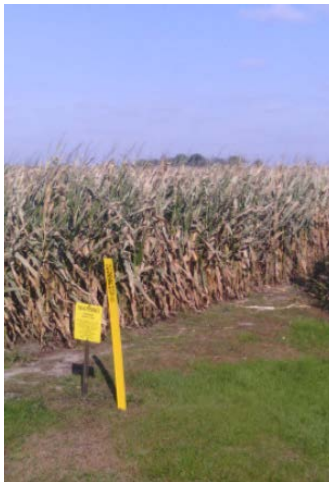
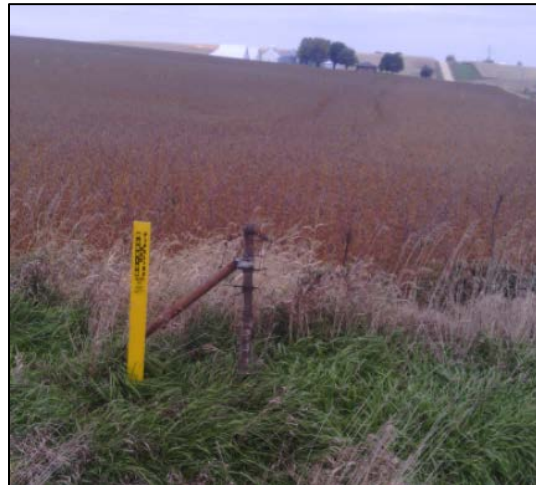
- 1) East of DRS 214, 230<sup>th</sup> St  
DeWitt
- 2) Intersection of 280<sup>th</sup> Ave & 175<sup>th</sup> St

The field inspection found four markers which were either missing information or illegible:

*MidAmerican replaced the pipeline markers at the following locations:*
