Iowa Utilities Board

MEC Bettendorf Unit GT Inspection (Revised)

Inspection Systems: Bettendorf Unit Gas Transmission Pipelines

Inspection Name: Insp-MEC-Bettendorf-GT-2019

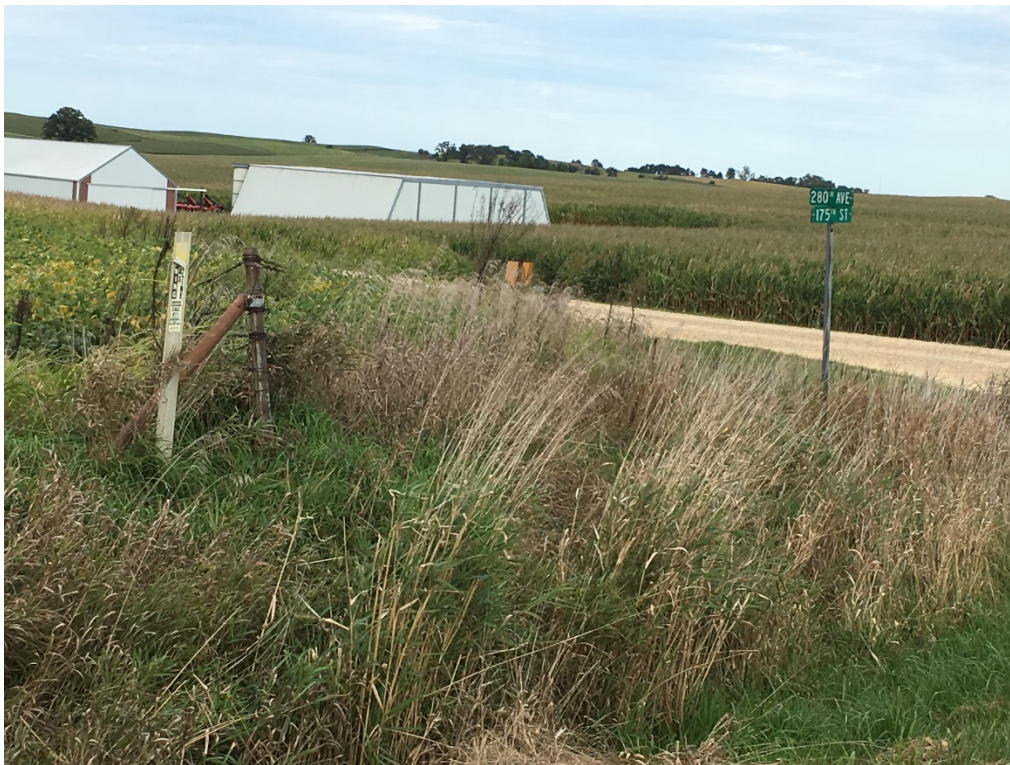
Issue Summary **Probable Violation 192.707(d)(1)**

Result Notes The field inspection found four markers which were either missing information or illegible:

1. East of DRS 214, 230th St, DeWitt
2. Intersection of 280th Ave & 175th St
3. West of 280th Ave and 175th St

4. At TBS 38, Muscatine

Example of a Marker Post found with missing information

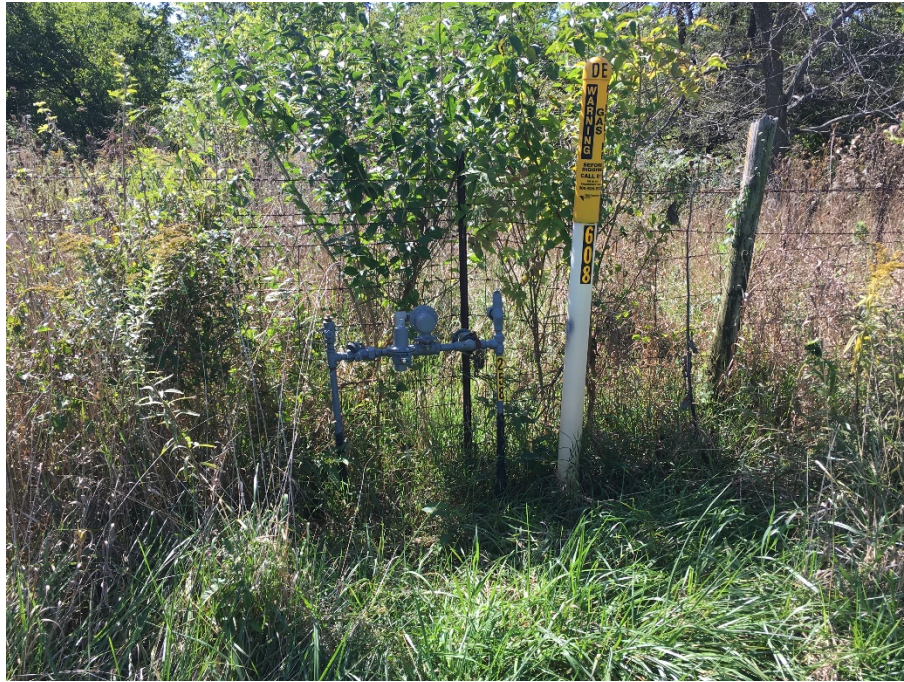
Issue Summary **Advisory: 192.705(b)**

Result Notes The overgrowth and foliage within pipeline ROWs on the 14 transmission lines in the Quad Cities Unit are cleared on a seven year cycle by company choice. Some specific areas were found to contain some extra heavy foliage with small trees and shrubs blocking the sightline. Patrolling records do not reflect ROW foliage as found in the inspection. The four locations having examples of inadequate access to observe surface conditions are:

1. Line 602 Scott College near Culinary School building
2. Line 602 Goose Creek crossing
3. Line 611 ROW along 39th St & South to Central Ave
4. Line 608 from DRS 3 south two miles.

Example of an overgrown right-of-way.
